PIC18F26/46/56Q83 Silicon Errata and Data Sheet Clarifications

PIC18F26/46/56Q83

Introduction

The PIC18F26/46/56Q83 devices that you have received conform functionally to the current device data sheet (DS40002253**D**), except for the anomalies described in this document.

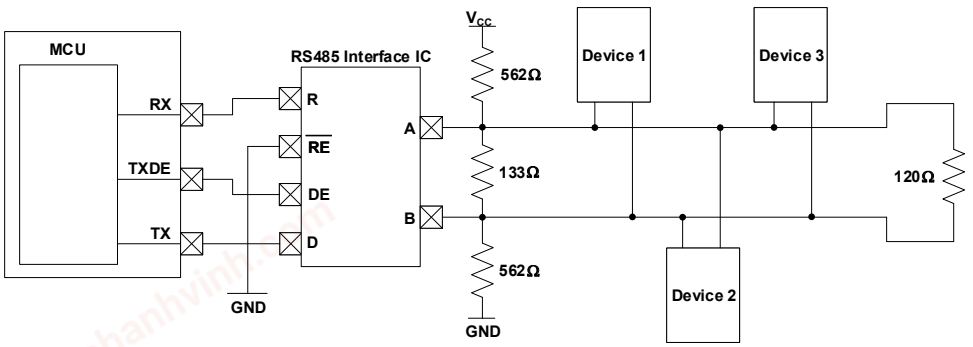
1.6.1. UART TXDE Signal May Go Low Before the STOP Bit Has Been Entirely Transmitted

The UART Transmit Drive Enable (TXDE) signal could potentially transition into a low state before the UART Stop bit has been entirely transmitted due to the effects of parasitic capacitance on the TX line. In some applications, this could result in communication being prematurely terminated due to the TXDE signal going low before the STOP bit has had enough time to settle.

To ensure that the Stop bit settles into its final logic state before the TXDE signal transitions low, a biasing circuit can be implemented. A biasing circuit allows the TX line to either be driven high or low, rather than being left in a floating tri-state mode, where prolonged rise or fall times could lead to communication being disrupted. This bias circuit must only be implemented on one end of the serial bus, and a termination resistor must be used on the other end. The figure below shows an example of a bias circuit that can be used to achieve this.

Please note that the resistor values used in this circuit are recommendations and that the actual resistor values required may vary based on the application.
