PIC18F27/47/57Q83 Silicon Errata and Data Sheet Clarifications

PIC18F27/47/57Q83

Introduction

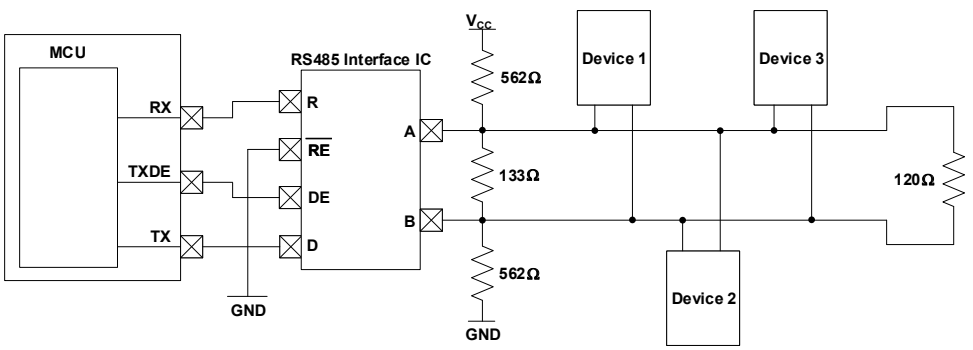
1.6.1. UART TXDE Signal May Go Low Before the STOP Bit Has Been Entirely Transmitted

The UART Transmit Drive Enable (TXDE) signal could potentially transition into a low state before the UART Stop bit has been entirely transmitted due to the effects of parasitic capacitance on the TX line. In some applications, this could result in communication being prematurely terminated due to the TXDE signal going low before the STOP bit has had enough time to settle.

To ensure that the Stop bit settles into its final logic state before the TXDE signal transitions low, a biasing circuit can be implemented. A biasing circuit allows the TX line to either be driven high or low, rather than being left in a floating tri-state mode, where prolonged rise or fall times could lead to communication being disrupted. This bias circuit must only be implemented on one end of the serial bus, and a termination resistor must be used on the other end. The figure below shows an example of a bias circuit that can be used to achieve this.

Please note that the resistor values used in this circuit are recommendations and that the actual resistor values required may vary based on the application.
