PIC18F24/25Q10 Silicon Errata and Data Sheet Clarifications

PIC18F24/25Q10

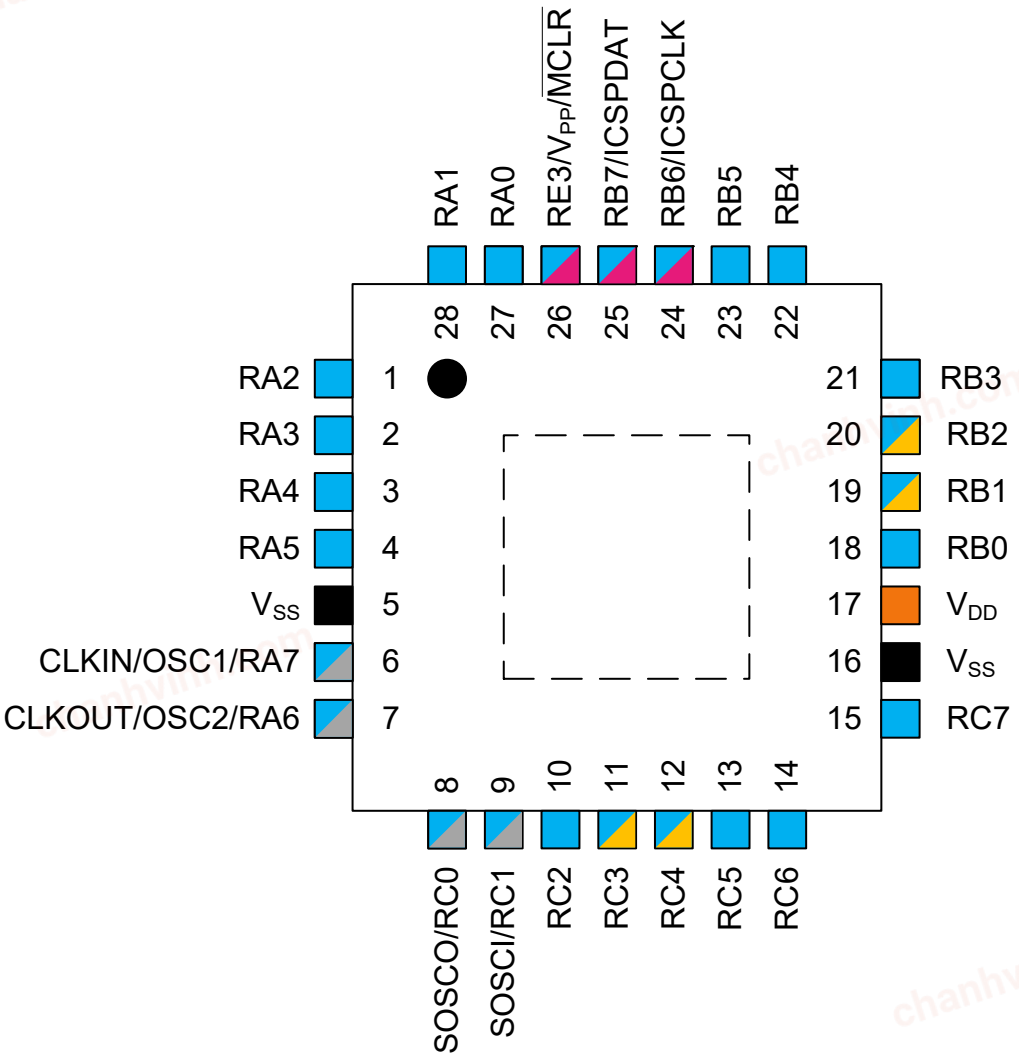
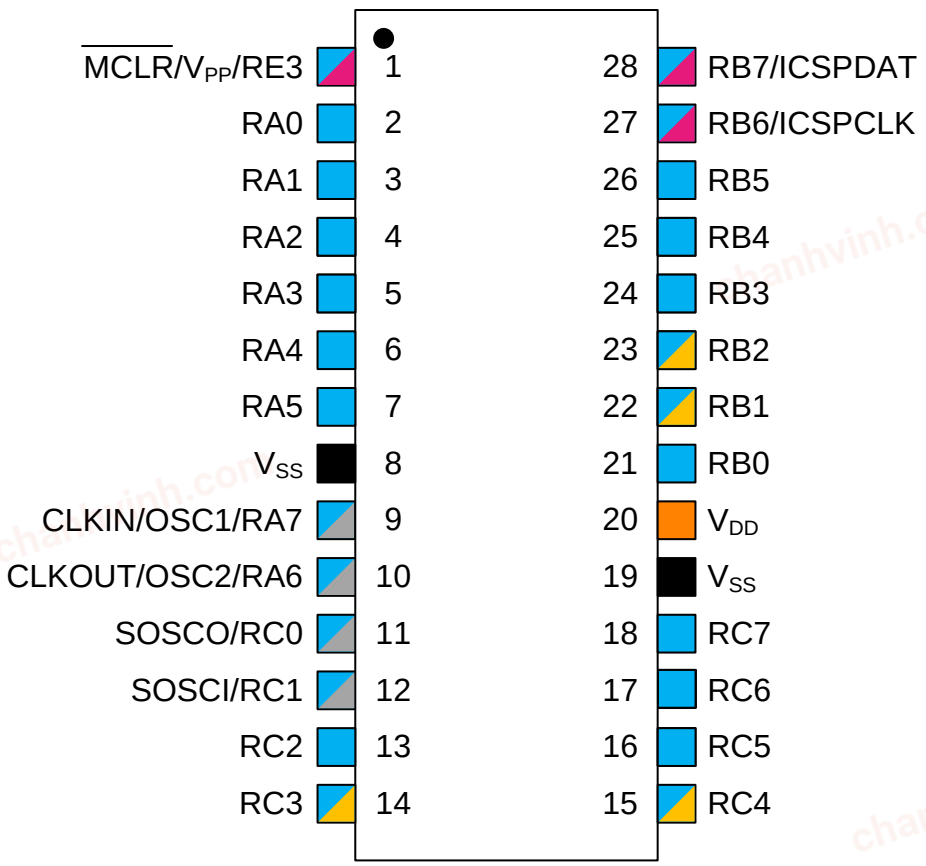
2.1. Pin Diagrams

The pin diagrams for the 28-pin packages have changed. Figures 1-1 and 1-2 in the data sheet have been updated as follows:
